### TITICUS DAM

WESTCHESTER COUNTY, NEW YORK  
INVENTORY NO. 50

### PHASE I INSPECTION REPORT NATIONAL DAM SAFETY PROGRAM

Name of Dam: TITICUS DAM (I.D. No. 50)  
State Located: NEW YORK STATE  
County Located: WESTCHESTER COUNTY  
Stream: TITICUS RIVER  
Date of Inspection: 24 APRIL 1978

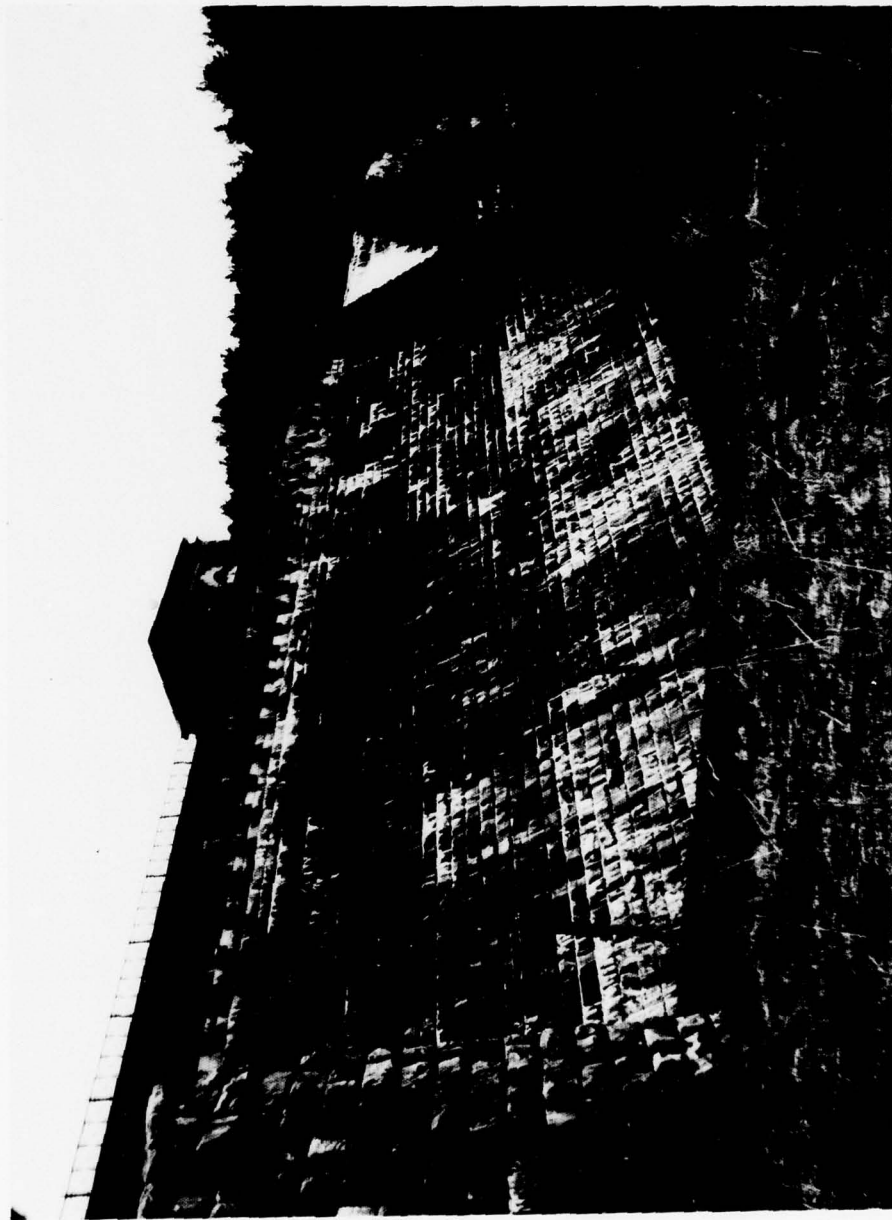
OVERVIEW OF MASONRY DAM AND SPILLWAY

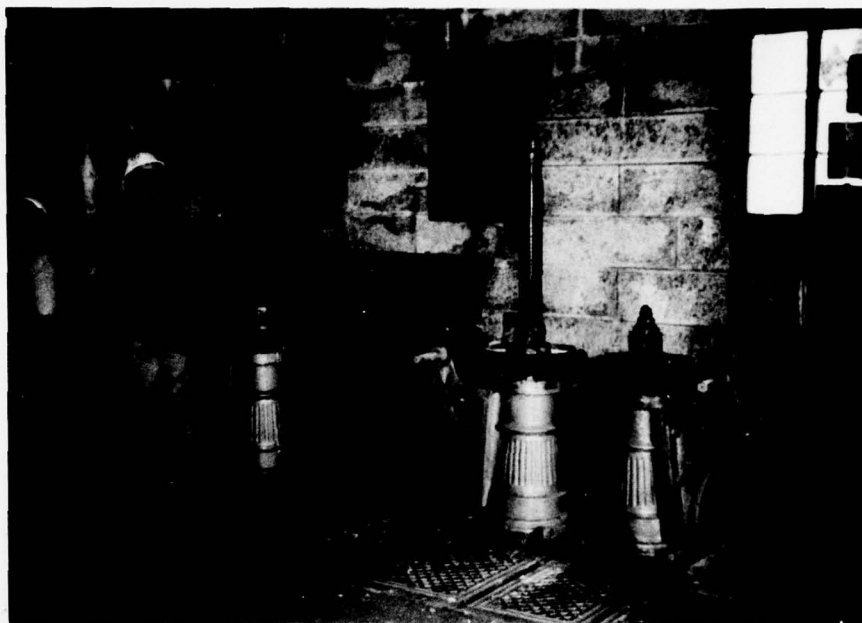
GATE OPERATING STANDS, SOUTH DIVISION OF GATEHOUSE

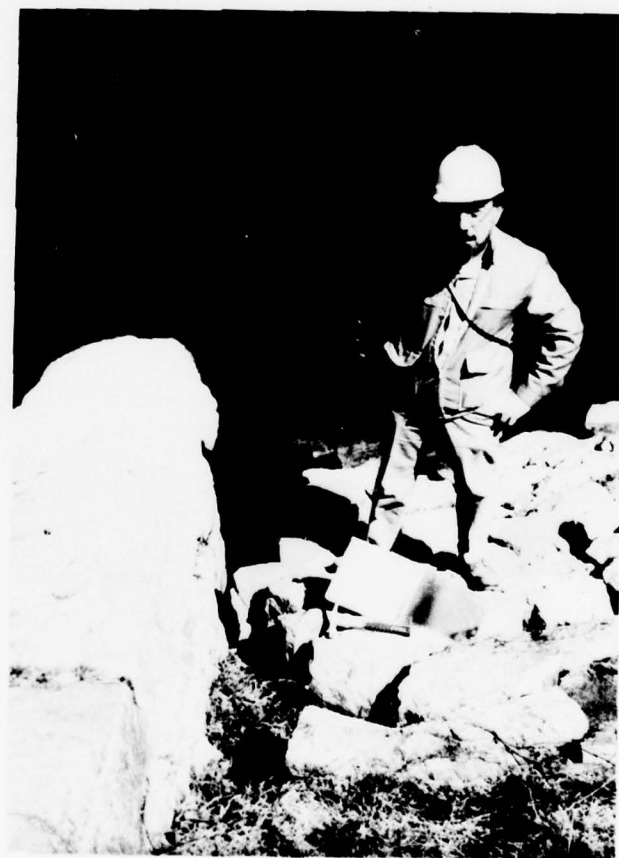
There was no sign of sloughing, erosion, cracking or other distress on the upstream slope and visible portion of the riprap of the north embankment. There are indications of minor downslope movement of the riprap, below the top course of stone, on the south embankment near the spillway approach wall. The affected area is limited to a section from the wall to a distance 25 ft south of the wall, with the maximum downslope movement of 1.0 to 1.5 ft occurring at a location approximately 15 ft south of the wall. There appears to be a 4 to 9 inch separation between the north edge of the riprap paving stones and the south face of the south spillway approach wall.

SEPARATION OF RIPRAP FROM S. SPILLWAY APPROACH WALL, SOUTH EMBANKMENT

(a) Condition of Riprap Generally good, except for 25 ft  
section on south embank. abutting spillway  
approach wall, 9 inch u/s movement

a. Monitoring of riprap and cracking of the masonry retaining walls, as called for in Section 3.2, should be initiated and continued on a periodic basis.

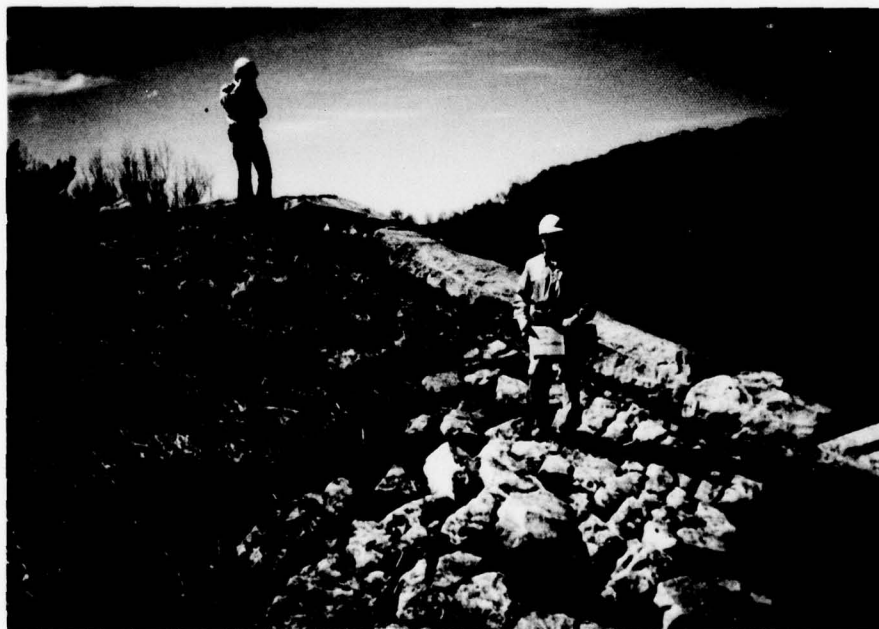
DOWSLOPE MOVEMENT OF RIPRAP, SOUTH EMBANKMENT

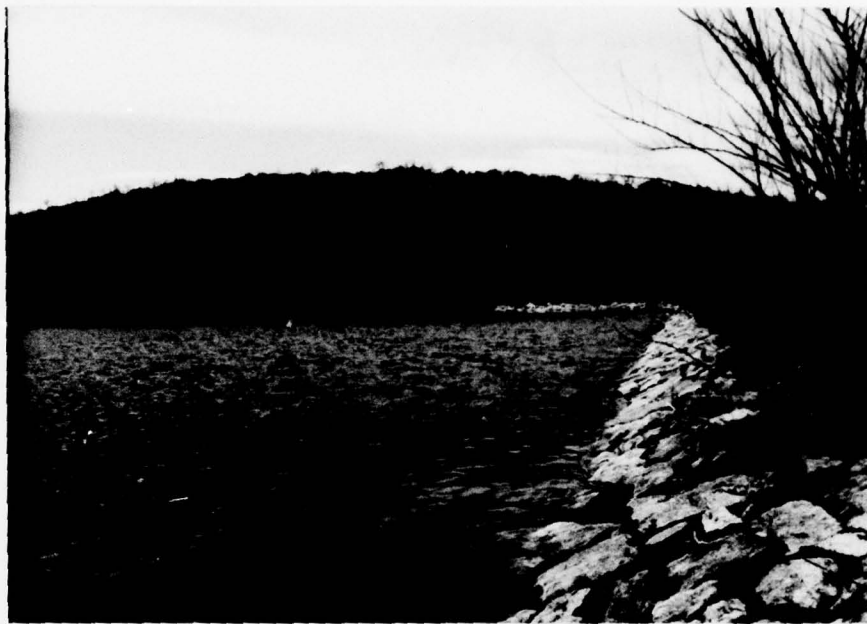
UPSTREAM SLOPE OF NORTH EMBANKMENT

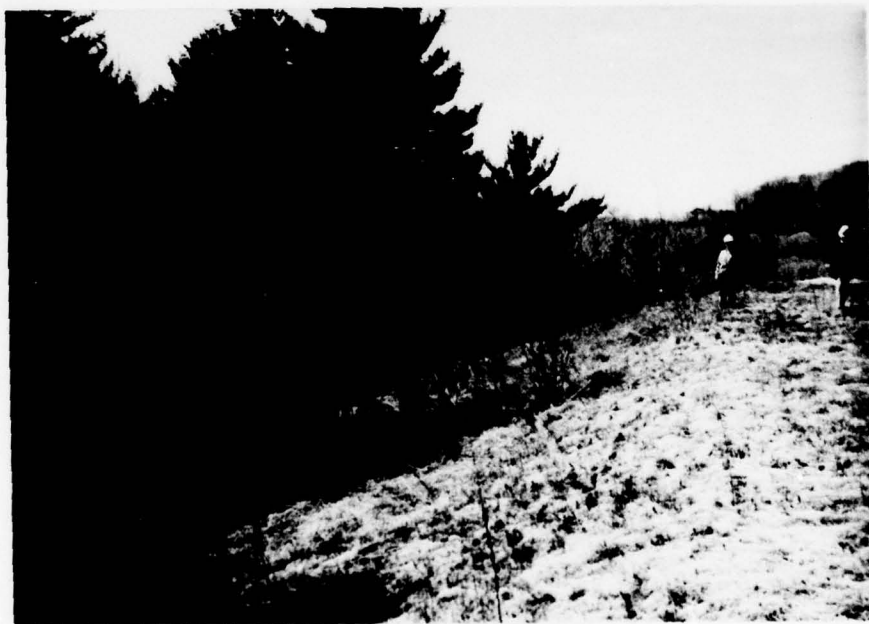
There were no visible signs of sloughing, erosion, cracking or other distress on the crest and downstream slopes of the embankments except for some ruts and other depressions caused by traffic.

DOWNSTREAM SLOPE OF SOUTH EMBANKMENT
